Published annually by The APSARA National Authority

លេខ ១, ឆ្នាំ២០១៩ / Number 1, 2019 / Numéro 1, 2019

អាជ្ញាធរជាតិអប្សរា APSARA National Authority

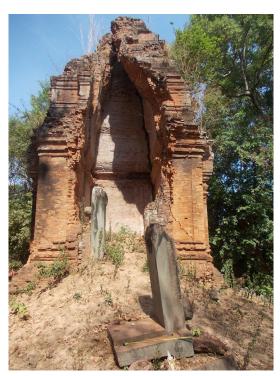
រូប៣៖ ការរលុះបាក់ខ្ចោងទ្វារនៃរូតទី៣ ប៉មជ្រុងឦសាន

រចនាសម្ព័ន្ធខ្វោងទ្វារខាងកើតនៃប៉មឥដ្ឋលេខ៤ ដួលរលំបាក់ទាំងស្រុងក្នុងខែតុលា ឆ្នាំ២០០៩នាក់ឡុង ពេលភ្ជៀងឆ្នាក់ខ្វាំង។ ទម្ងន់ផ្ដែរនិងហោជាង ផ្ដល់នូវបន្ទុកដ៏ធ្ងន់សង្កត់មកលើក្បាលសសរផ្ដោបទាំងសង្ខាង ដែលកំពុងមានស្ថានភាពផុយស្រួយស្រាប់ ហេតុនេះ ទឹកភ្វៀងជ្រាបចូលដល់ស្រទាប់ឥដ្ឋខាងក្នុងតាមរយៈស្នាម ប្រេះនៃសសរផ្ដោប(រូប៦) ធ្វើឲ្យកម្វាំងស្អិតរវាងសម្ព័ន្ធដុំឥដ្ឋនីមួយៗចុះខ្សោយ ហើយរអិលចេញនិងរុញច្រាន ឬផ្ដែរដ៏ធំរលំបាក់ជាកំណាត់ៗរួមទាំងសសរផ្ដោប សសរពេជ្រ និងឬខឿនជណ្ដើរ។ល។ក៏រងការបាក់បែកដូចគ្នា (រូប៧)។

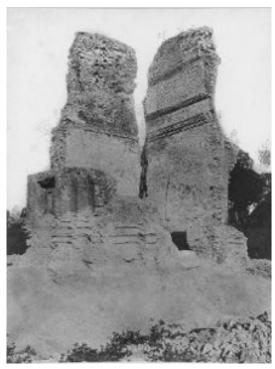
រូប៤៖EFEO-CAM07775-1936 ជញ្ជាំងប្រេះហែកជាពីរ នៃប៉មជ្រុង អាគ្នេយ៍(ចំណុច១៧)

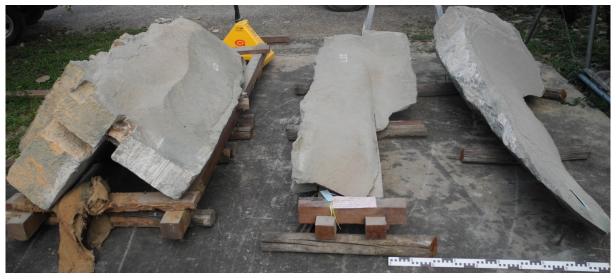
រូប៦៖ ស្នាមប្រេះលើសសរផ្ដោបនៃប៉មលេខ៤ប្រាសាទបាគង៍

និងជំនួសវិញនូវសម្ភារៈថ្មី ប្រភេទបង្កឹះកែវ (Glass Fiber) និងប្រភេទដែកមិនច្រេះ (Stainless Steel) ដែលនាំចូលពីបរទេសដូចជា ប្រទេសអាឡឺម៉ង់ អ៊ីតាលី កូរ៉េនិងប្រទេសចិនជាដើម។ ស្នូលប្រភេទថ្មី (Glass Fiber)មានទំហំប្រែប្រួលចាប់ពី២មីលីម៉ែត្ររហូតដល់២០មីលីម៉ែត្រមានគុណភាពស្វិតរឹងមាំ មិនរង់អុកស៊ីតកម្ម ឬបង្កភាពច្រេះឡើយ ហើយត្រូវបានជ្រើសរើសយកមកប្រើក្នុងតួនាទីដើម្បីតភ្ជាប់ថ្មឬថ្លក់(ណ្ឌក់)ពីផ្នែកមួយ ទៅផ្នែកម្ខាងទៀត។ គ្រប់ទំហំនៃស្នូលចង្កឹះកែវនេះ ត្រូវយកទៅប្រើប្រាស់សម្រាប់អនុវត្តជួសជុលពង្រឹងប៉ម លេខ៤ប្រាសាទបាគង់ត្រង់ទីតាំងខុសៗគ្នា ដូចជា តភ្ជាប់បំណែកថ្ម ពង្រឹងស្នាមប្រេះលើជញ្ជាំង សសរពេជ្រ និងសសរផ្សាបទាំងសង្ខាង(ឬងំ៦)។

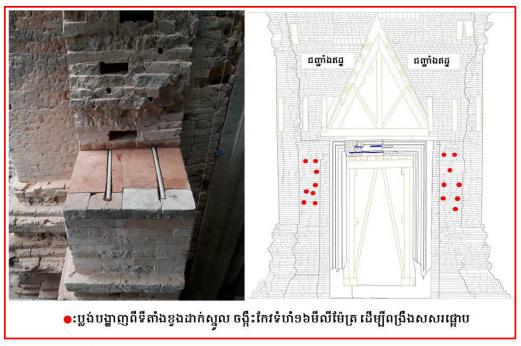
ឬងំ៦៖ ខ្ចោងទ្វារនៃប៉មឥដ្ឋលេខ៤ ប្រាសាទបាគង៍

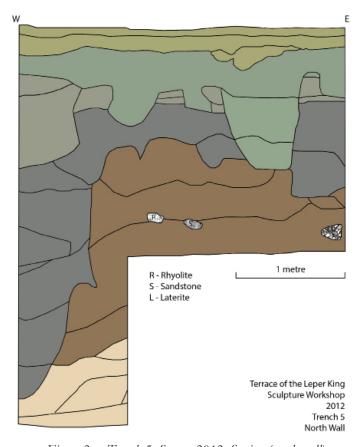
Figure 2. – Trench 5. Season 2012: Section (north wall)

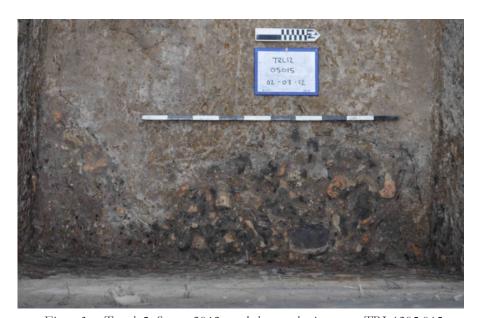
Figure 3. – Trench 5. Season 2012: workshop production waste. TRL1205.015.

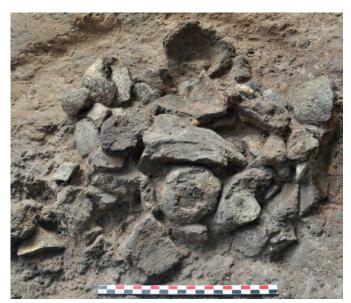
Figure 4. – Deposit of individual crucible fragments. TRL1302B.010/1. Photo: Chunn Sambor.

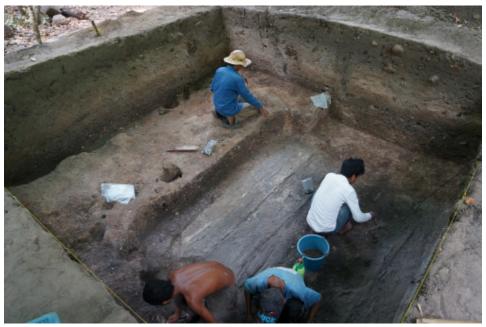
Figure 11. – APSARA Archaeologists at work on the Royal Palace bronze workshop Angkor Thom.

furnaces, this find confirms the use of a complementary technique for melting copper-based alloys. One structure is a circular bowl or basin of fired clay approximately 50 cm in diametre. It is partially preserved and equipped with one *in-situ* inclined tuyère on the western side. Copper-based alloy appears as an inclusion in the tuyère, and droplets within the basin. Many fragments of wall furnace, with red fired clay on one side and highly vitrified clay on the other, were found on the southern side of the structure, perhaps the top of the furnace chamber discarded after its destruction. Adjacent and northwest to the basin furnace another structure of fired clay with an oblong shape is also partially preserved. A protruding clay support on the eastern side and the absence of copper-based alloy remains might suggest a crucible furnace that utilised a clay grate. Similar furnace technology was observed in the Udong region in the 1960s and 1970s (Mourer 1980: 336, fig. 2, Dupaigne 1987: 601–602). Two additional basin-like structures might constitute a battery of furnaces simultaneously supplying metal for large castings, likely of sculptures. Consequently, this location will be an excavation priority of future campaigns.

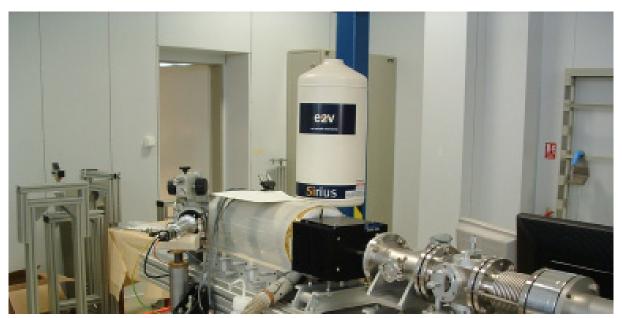
Fig. 1 This photo shows the terminal of the proton beam line with quadrupole magnets focussing the beam on the sandstone sample, beam scanner and the cooling system of the quadrupoles. The target chamber, positioned at the end of the proton beam line, was equipped with the X-ray Si(Li) and RBS detectors.

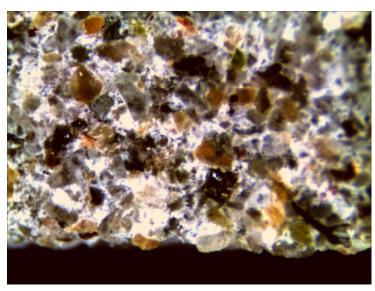
Fig. 2 shows the microstructure of the sandstone where the lower edge is the surface of the block the core sample was taken from.

The microstructure of the sandstone samples was first examined under a classical light microscope to select a part of the core sample that would be most suitable for a subsequent investigation with the proton beam of the micro-PIXE. The microstructure of the sandstone sample is depicted below in Fig. 2.

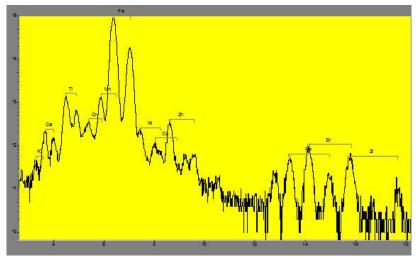
Fig. 3 The spectrum of the PIXE analysis showing the representation of individual elements in the scanned sandstone sample. The abscissa shows the energy of the recorded signals and the ordinate corresponds to the No. of counts detected at each particular energy level. The individual peaks are marked with symbols designating each particular element (e.g. Fe) with known emission energy.

A typical spectrum of the measured signals emitted by the sample after proton irradiation of the sandstone surface is shown below.

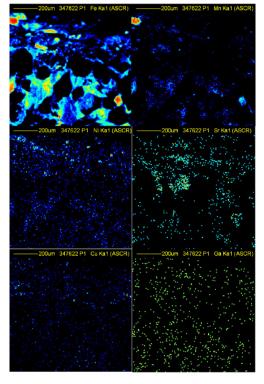
Fig. 4 The six panels show the element maps for Fe, Mn, Ni, Sr, Cu and Ga. The scale is depicted by the bar in each panel. The dots show the locations of individual counts and the colour scale depicts the count density of photons emitted from each particular location. The redder the colour, the higher the frequency of the photons emitted by the activated elements. The only prominent high concentration pattern appears in the two middle panels for Ni and Sr. The peak concentration are not co-localised either with each other or with the distributions detected for Fe and Mn.

From Fig. 4, we can discern the different distribution patterns for each of the six elements depicted. The concentration of Fe is very high in some locations but totally absent in others. The concentration of Mn is as high as that observed for Fe but only in one particular location (near the upper left corner of the panel). The distribution pattern otherwise approximates that of Fe, indicating that these two elements are co-localized. The remaining two panels (shown at the bottom of Fig.4) show rather diffused distributions for the two measured elements (Cu and Ga) and a rather low density of the counts. This distribution indicates a rather low and nonspecific concentration of the two elements in the analysed sandstone sample.

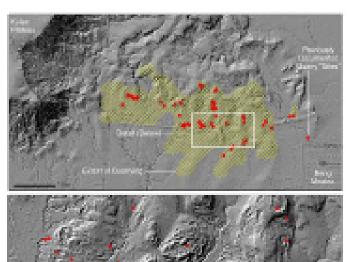
Fig. 5: Extent of the vast quarry field between Beng Mealea and Phnom Kulen as revealed by the 2015 lidar imagery, compared to the previous view of discrete quarries as identified by Uchida and Shimoda (2013). Lidar imagery is composite elevation and hillshade models.

The 2015 data also provide new insights into relatively well-known archaeological sites. The quarries between Beng Mealea and Phnom Kulen, for example, have been the subject of inquiry since the 19th century, and are generally recognised as the main source of sandstone for Angkor's monuments. Canals have been traced linking the quarries to central Angkor, and one recent study by the Japanese team reported the 'discovery' of 'more than 50' discrete quarries in the area, with distinct groupings of individual quarries with different sandstone characteristics. In reality, as the lidar data clearly show (Fig. 5), the area between Beng Mealea and Phnom Kulen is essentially one enormous quarry field of ~500 ha with localised heterogeneity

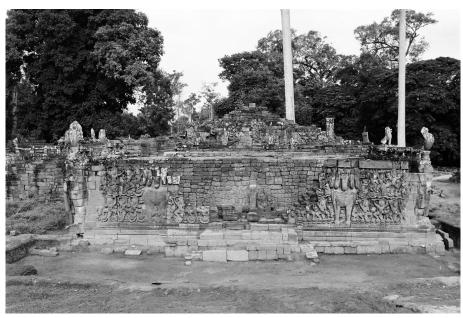
Photo 1: East facade of the North Stairway of the Terrace of the Elephants in 1997 during the restoration works. Note that M3 has been temporarily dismantled for complete anastylosis, revealing entirely the east side of M2. (©EFEO)

There were two additional features on the North Stairway: a carved-relief panel which we designated M4 and the base of a rather unusual *stupa* (photo 4). Anastylosis of M4 started in March 1997. As with most anastyloses, one of the more difficult tasks was to find the missing pieces from this three-dimensional jigsaw puzzle. While the structure was relatively small and the carvings made it easier to identify the stones, we had an unusually complex task for we had to address a fourth dimension—that of time—since the stairway had undergone several modifications.

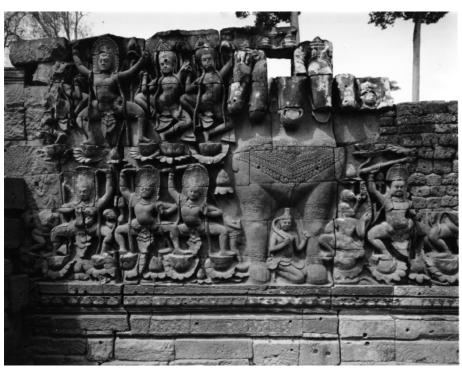
Photo 2: Southern half of M2 before restoration, during anastylosis of M3. (© J. Poncar)

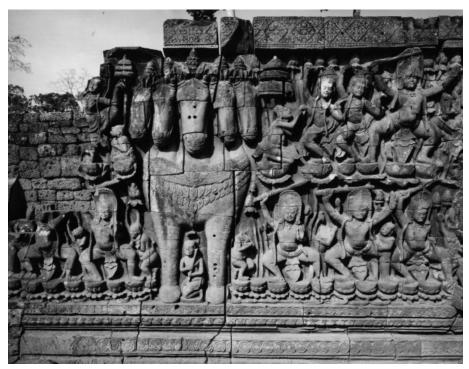
Photo 3: Northern half of M2 before restoration, during anastylosis of M3. (© J. Poncar)

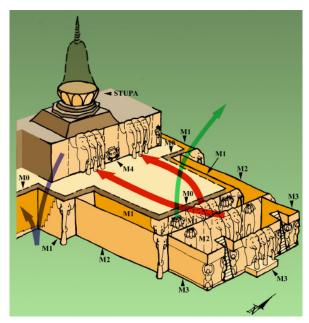
Figure 1: Overview of the different features and modifications at the North Stairway of the Terrace of the Elephants. (©EFEO)

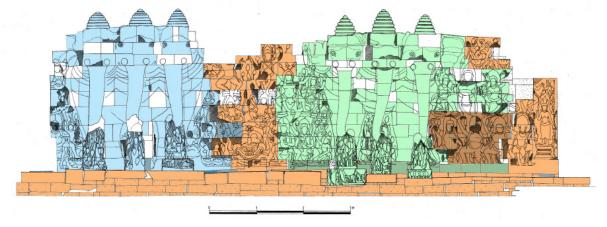
Figure 2: M4 after restoration. Origin of the stones: pale blue from M2; dark blue misplaced from M2; pale green from M1, dark green misplaced from M1, orange are re-used stones from unidentified location and sculpted during the construction of M4; dark orange are stones from M1 central panel but re-sculpted during the construction of M4; white are new stones. (©EFEO)

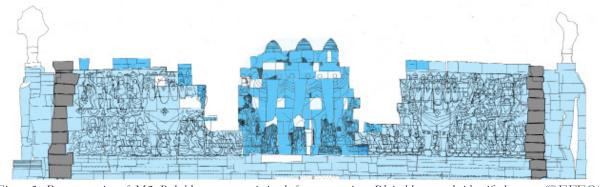
Figure 3: Reconstruction of M2. Pale blue: stones existing before restoration; Plain blue: newly identified stones. (©EFEO)

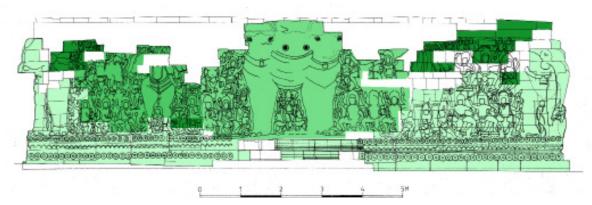
Figure 4: Reconstruction of M1. Pale green: stones existing before restoration; Plain green: newly identified stones from M4; darker plain green: stones identified at the Terrace of the Leper King; dark green: other newly identified stones. (©EFEO)

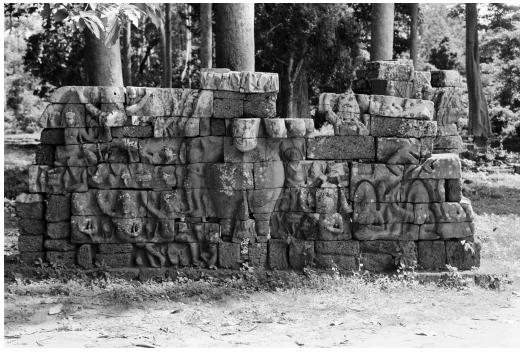
Photo 5: Relief panel reconstructed in 1996 on the north of the Terrace of the Leper King. (©EFEO)

On-site research during our anastylosis of the M4 panel enabled us to precisely determine the original location of the re-used reliefs: the southern half of M4 comes from the centre of the eastern panel of M2, while the northern half of M4 (between the Rahu and the corner *devata*) was originally the centre of M1's eastern panel (figures 2 to 4). Furthermore, a demolished relief panel found in the early 1900s on top of the Terrace of the Leper King, and now re-erected to the north of that Terrace, also comes from the eastern façade of M1 and would exactly fit into the vacant space in its southern half (photo 5 and figure 4).

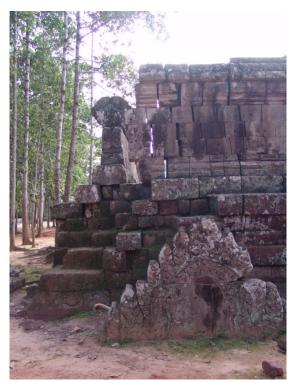
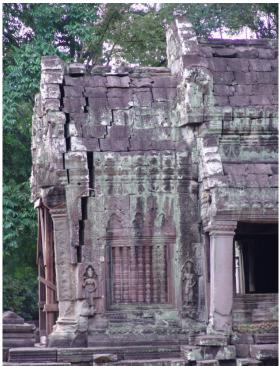
Fig. 1: Typical examples of the structural failures of the corner or end parts of monuments.

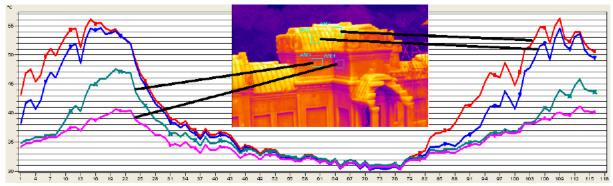
Fig. 3: The daily cycle temperature field on the surface of the monitored stone structures determined by thermographic monitoring.

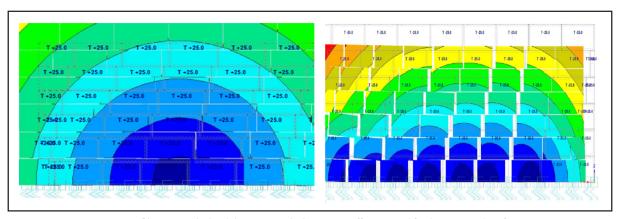
Fig. 4: Character of the deformation of the stone wall generated by heating and cooling.

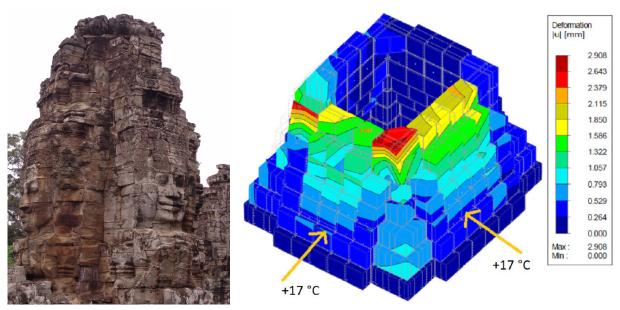
Fig. 5: One of the Bayon temple towers on approximately square ground plan damaged by disintegration of the sandstone masonry; simulation of the deformation and damage of the tower loaded by heating of the masonry on two sides.

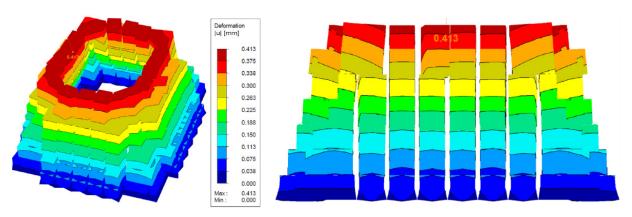
Fig. 6: Character of the deformation of the tower on rectangular ground plan with stress caused by cooling of the structure.

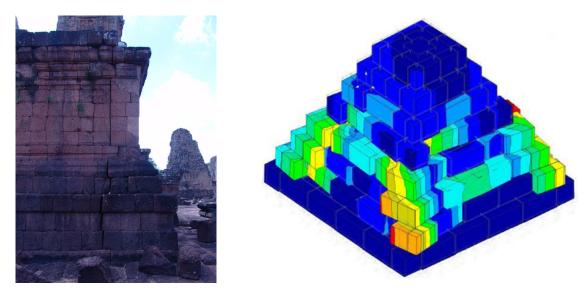
Fig. 7: Character of typical damage of a temple pyramid corner, an example of stone blocks displacement of simple model of the pyramid loaded by heating.

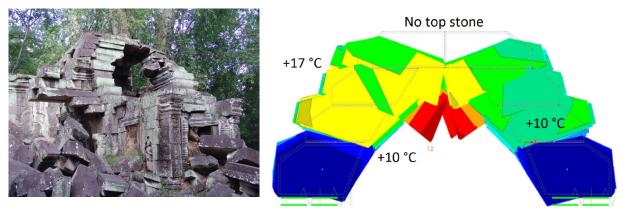
Fig. 8: Character of progressive collapse of vault structure, deformation of uncompleted vault loaded by self-weight and uneven warming

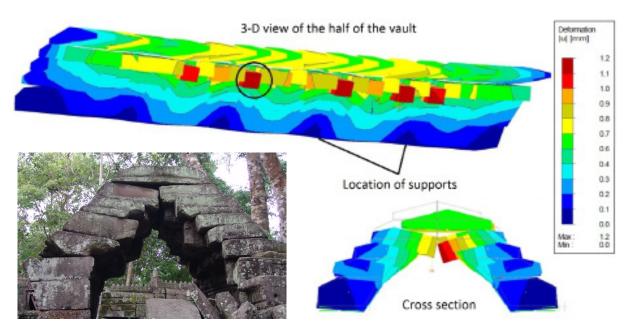
Fig. 9: Character of reshaping of the false vault loaded with self-weight.

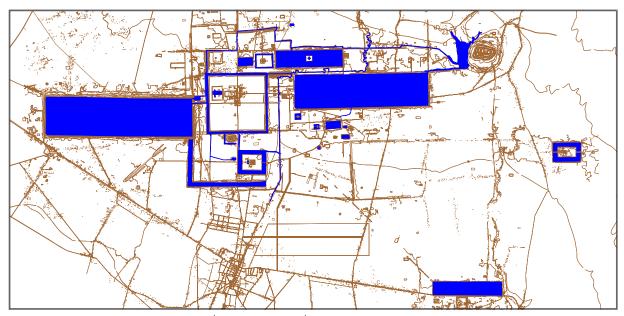
ប្រព័ន្ធធារាសាស្ត្រសម័យបុរាណក្នុងឧទ្យានអង្គរ

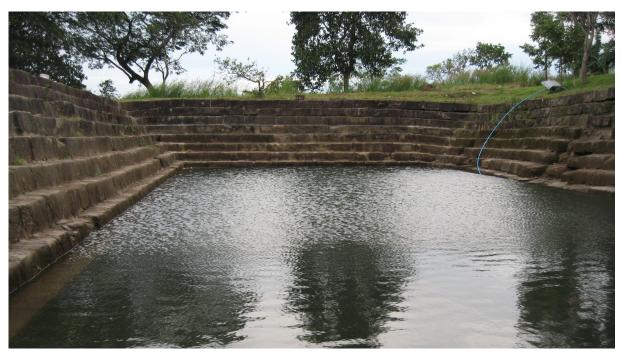
កម្រិតទឹកនៅខែវិច្ឆិកា ក្នុងអាងទី៥

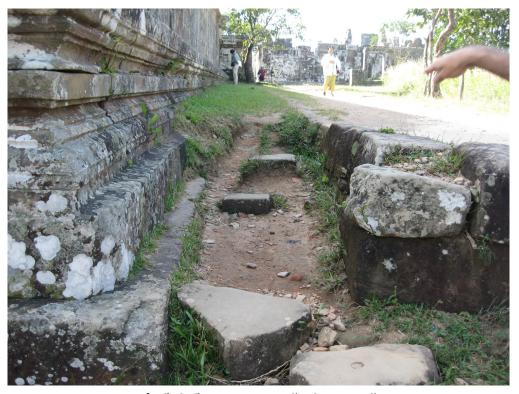
សំណឹករិចរឹលនៅចន្ទោះអាជទី១ និងគោបុរ:ទី৮

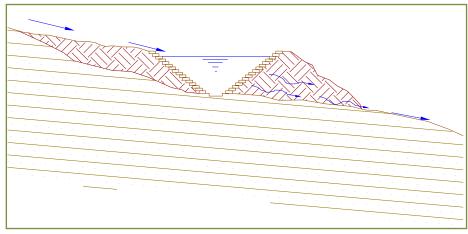
រូបភាពកាត់ទទឹងនៃអាងបុរាណ
